Debris/Ice/TPS Assessment and Integrated Photographic Analysis of Shuttle Mission STS-71

**DEBRIS/ICE/TPS ASSESSMENT
AND
INTEGRATED PHOTOGRAPHIC ANALYSIS
OF
SHUTTLE MISSION STS-71**

27 June 1995

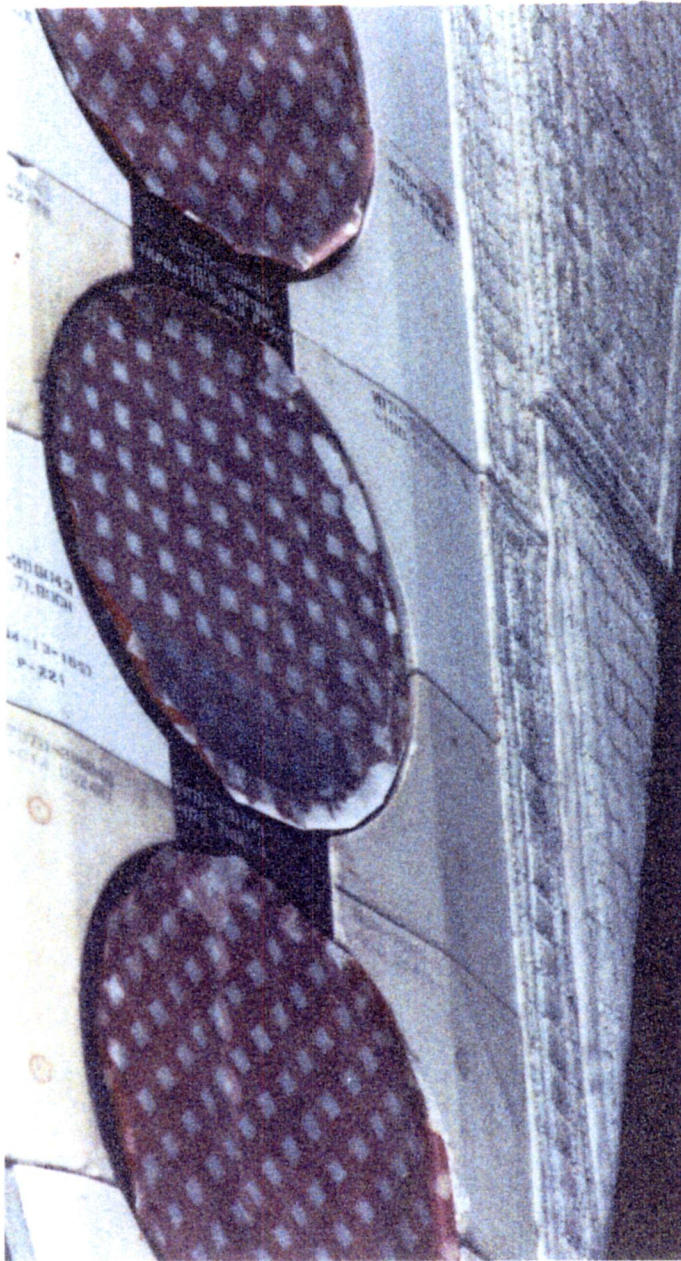
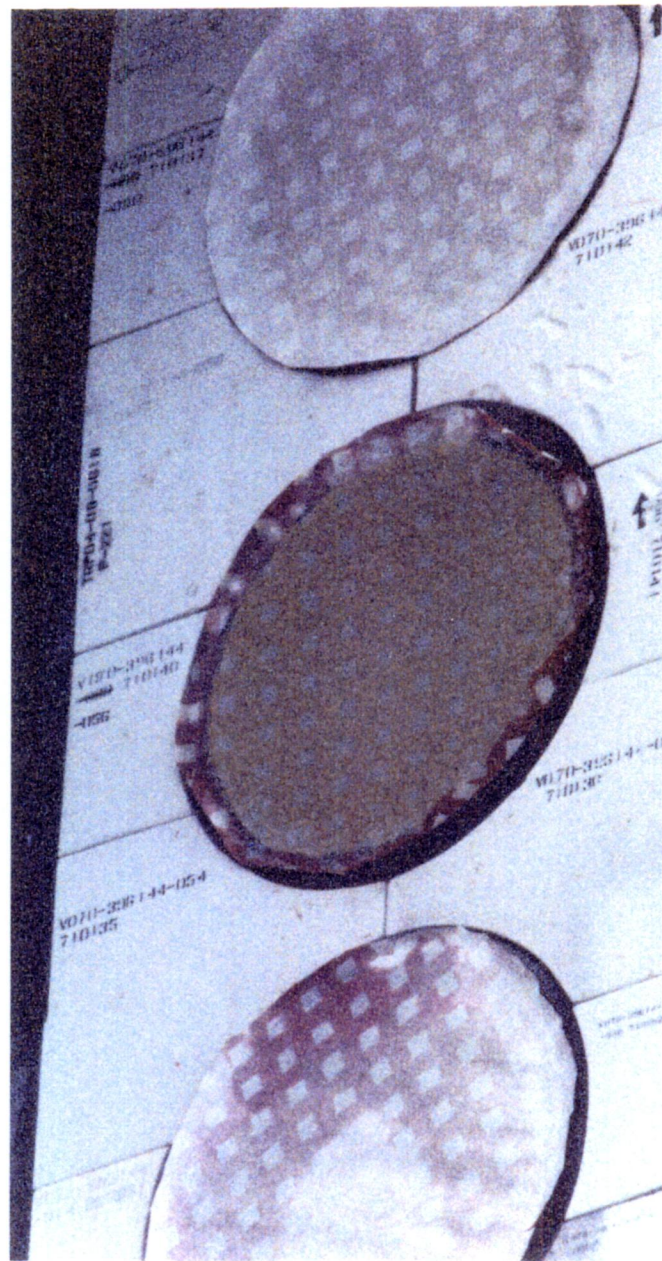
Photo 4 : Aft RCS Thruster Covers

Liquid, most likely water from recent heavy rain on the pad, was visible behind aft RCS thruster R3R. Paper covers on the L4D and R2U thrusters were tinted green, which is indicative of a slight vapor leak. These conditions were noted during the first launch attempt.

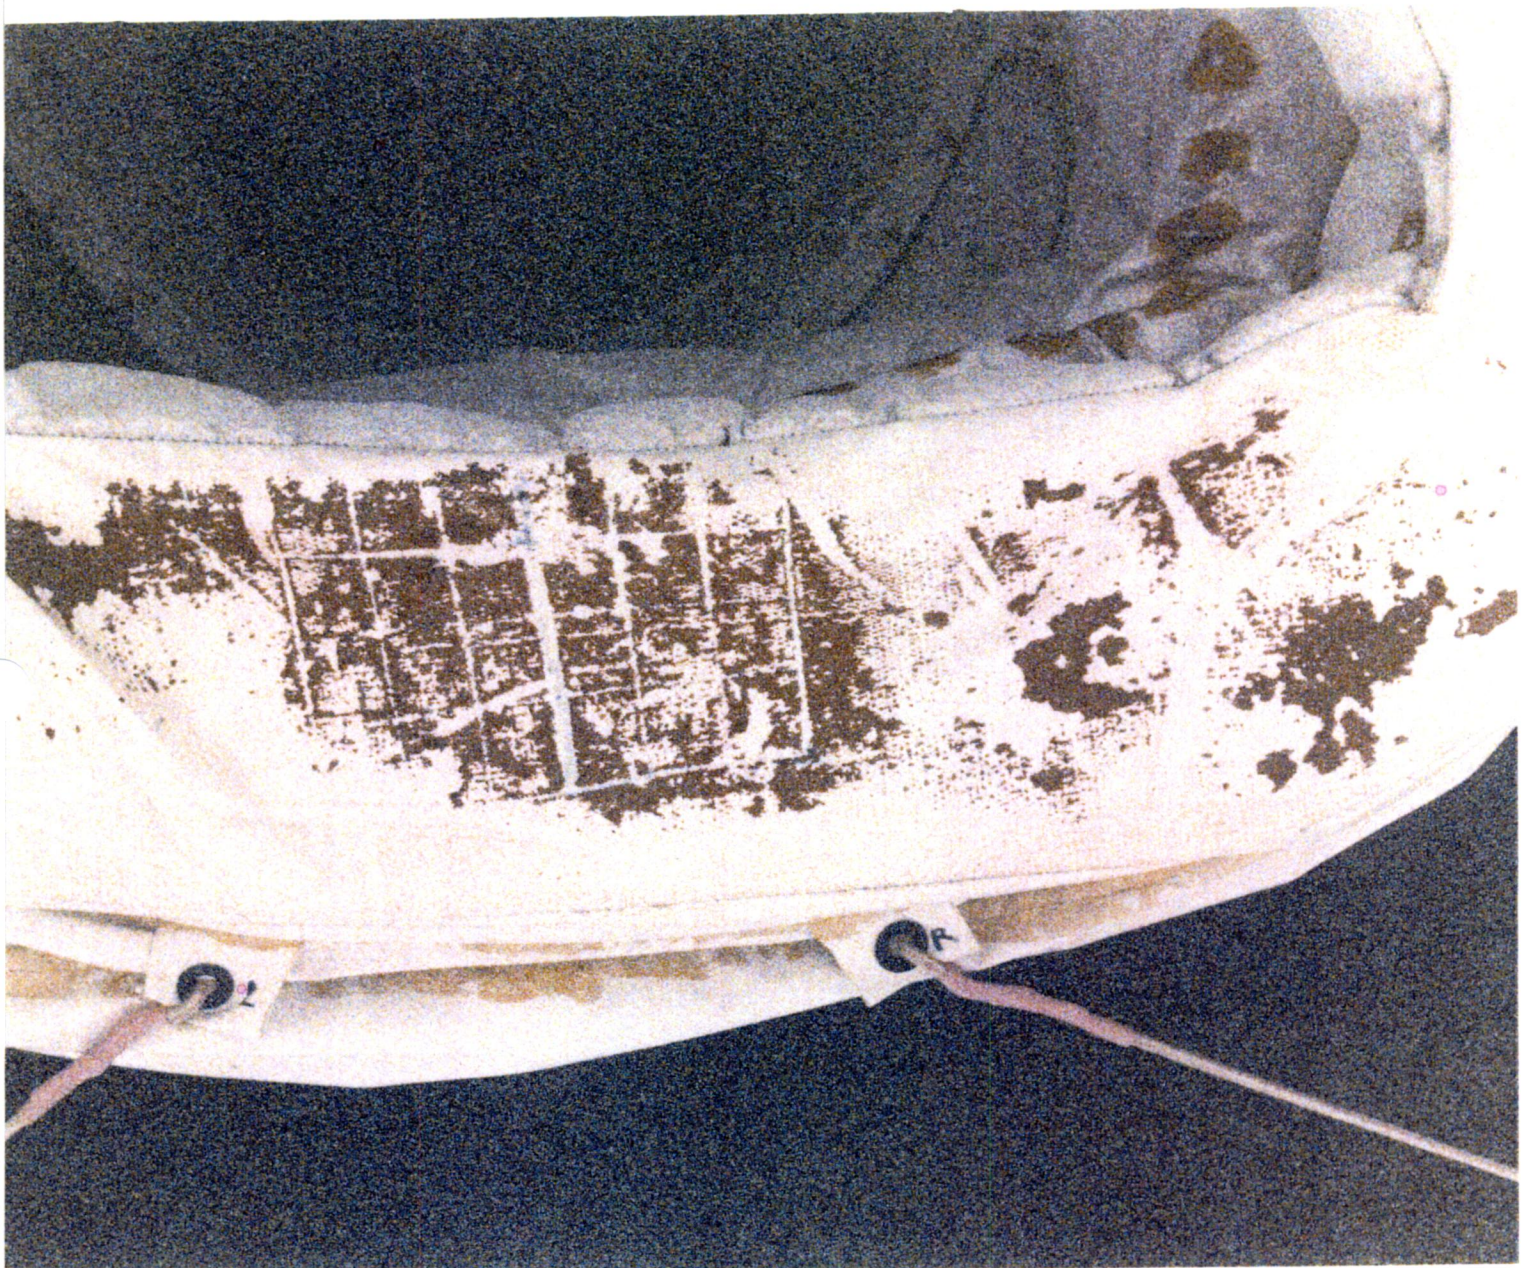
Photo 8 : Topcoat Adhered to -Y GOX Vent Seal

Topcoat adhered to GOX vent seals and was subsequently pulled up from the ET nose cone footprint area during GOX hood retraction. Post drain inspection found the missing topcoat, but no TPS, adhering to both GOX vent seals.

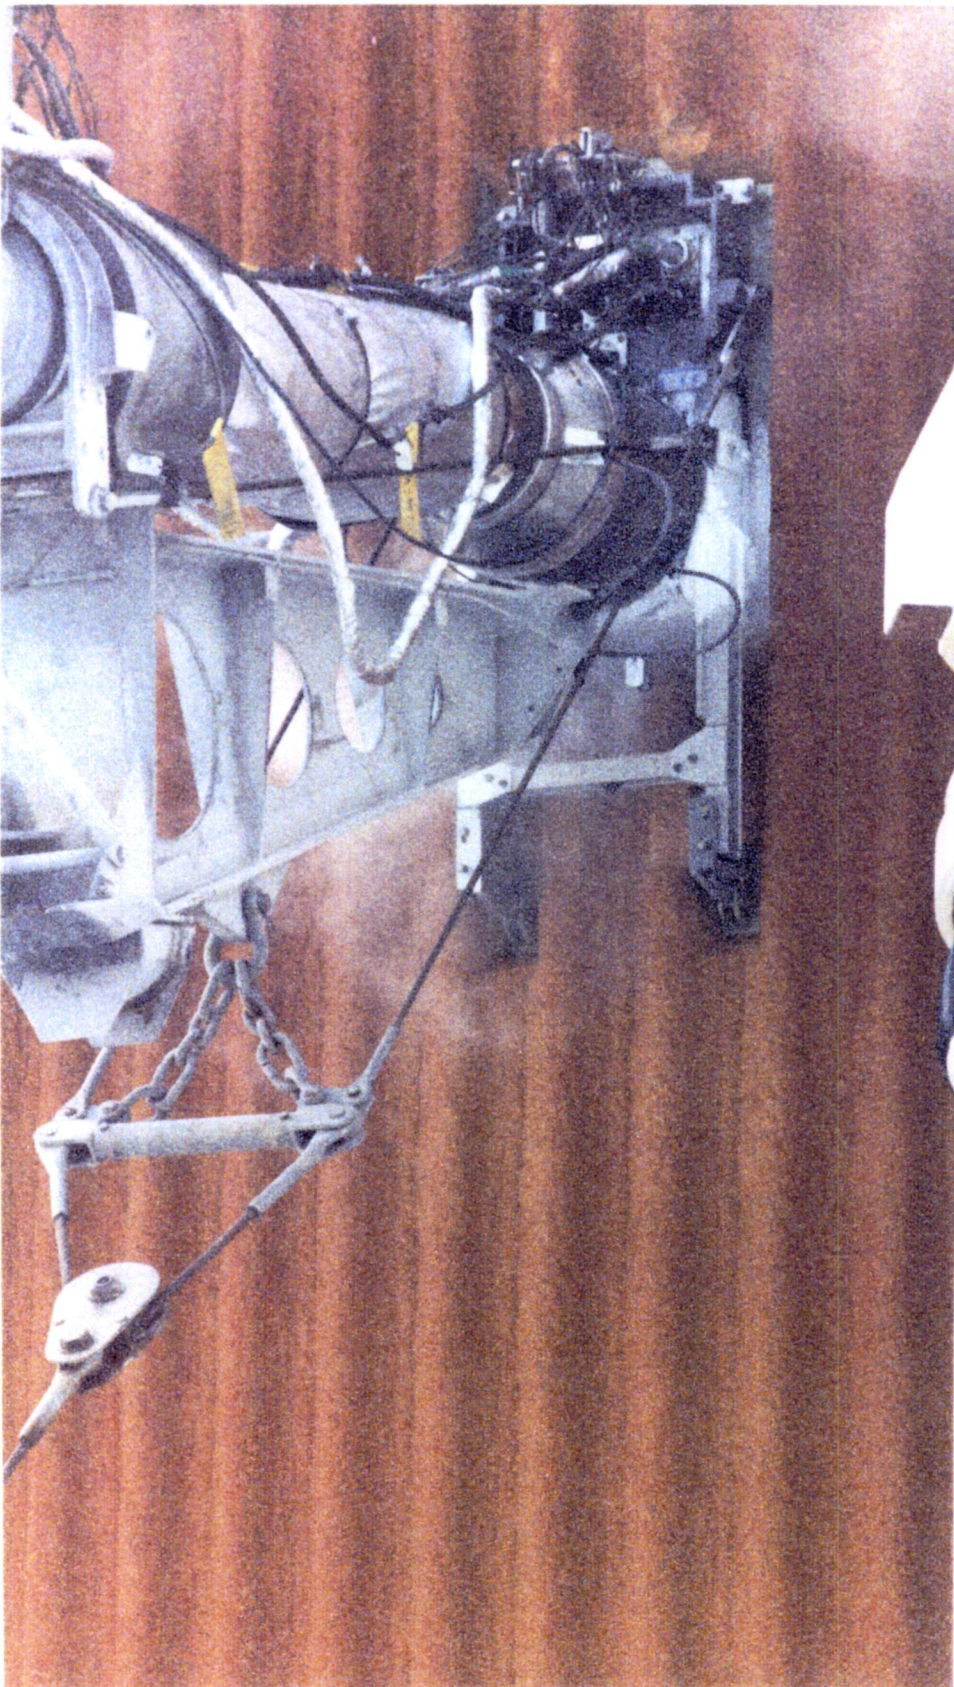
Photo 10: Liquid Air/Ice Formations on GUCP

More than usual ice/frost formations and venting vapors were present around the ET umbilical carrier plate. Liquid air drips seemed to originate from the ice suppression shroud area during cryoload, but stopped after ice and frost accumulated to form an ice insulation. The leak detectors gave no indication of an internal leak.

There was no visible damage to the GUCP or QD that may have contributed to the heavier-than-usual formation of ice/frost along with venting vapors and liquid air drops observed during cryo load. The seals were inspected closely during GUCP disassembly. All mechanical interfaces and bolts were checked. No cause for the liquid air drops was found.

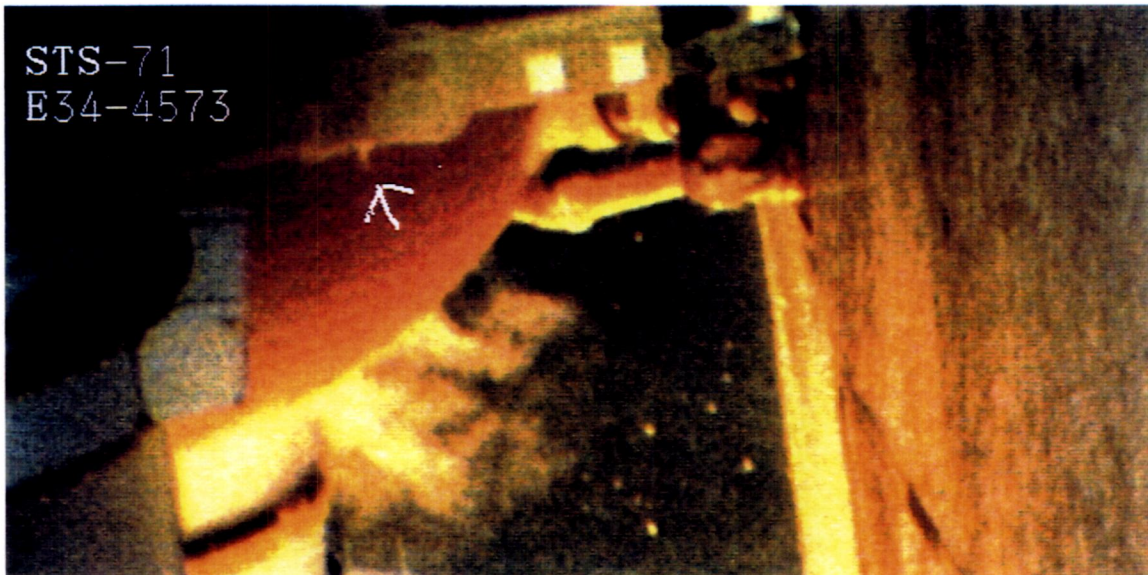
Figure 2.2.3 Vapors Coming from ET/SRB Strut Cable Tray Drain Hole

Vapors were seen coming from the -Y ET/SRB strut cable tray drain hole at liftoff. KSC reported that this was an expected occurrence due to the humid atmospheric conditions at the time of launch. No follow-up action was requested.

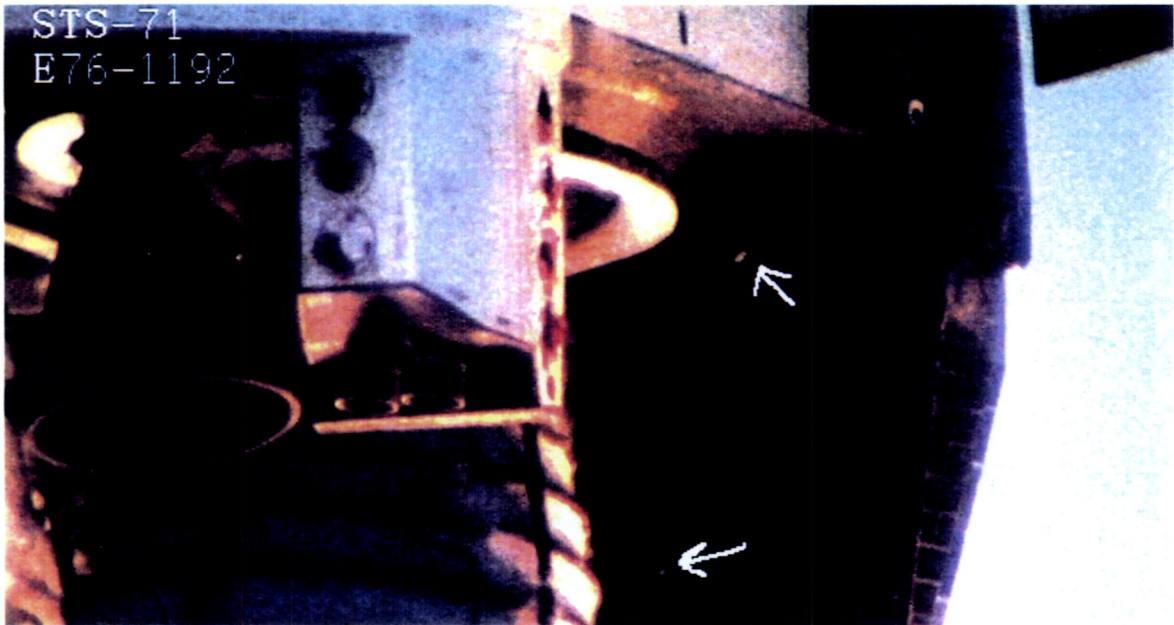
Figure 2.2.6 Tile Surface Coating Material Missing on +Z Side of Body Flap

KSC reported in their post landing inspection report that numerous tile damage sites on the +Z side of the body flap outboard of SSME #3 corresponded to sites identified in the launch film review and were caused by SSME ignition vibration/acoustics.
